Third River - FIBI043

SUMMARY OF RESULTS

FIBI043 - Third River

1. Stream Name:	Third River
2. Sampling Date:	06-18-2002
3. Sampling Location:	West Passaic Ave (40 50 00.36; -74 10 46.52)
4. Municipality:	Bloomfield Twp.

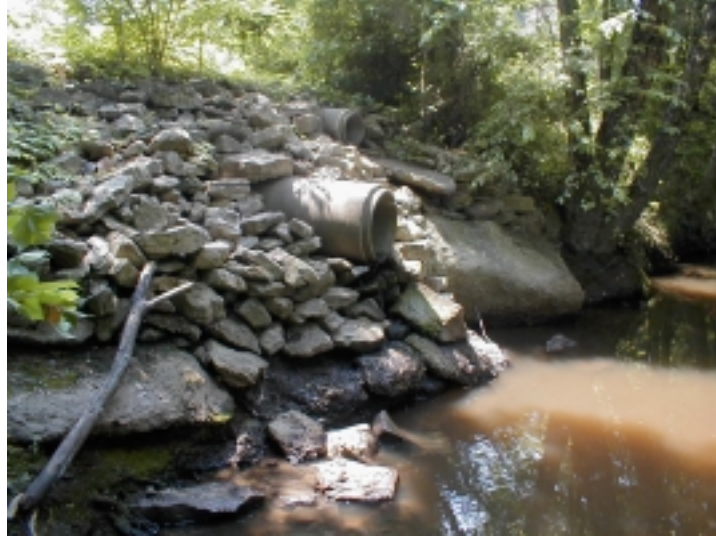
Stormwater runoff continues to impact the quality of the State's waterbodies by eroding banks and flushing pollutants, including floating debris (see below), into surface waters.

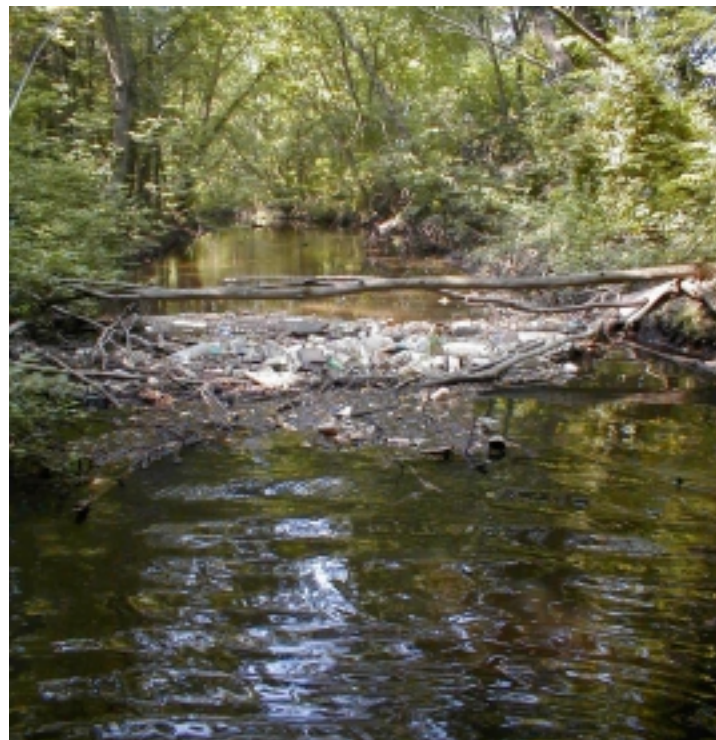
The amount of floating debris trapped behind these fallen branches highlights the impact that uncontrolled stormwater discharge has on waterbodies in urbanized areas.
